MONTANA DEPARTMENT OF TRANSPORTATION STREAM MITIGATION MONITORING REPORT

*Spring Creek
Flathead County, Montana*

*Project Completed: 2010
Monitoring Report #4: December, 2016*

MDT Project Number: NH-MT 5-3(59) 109
Control Number: 2038

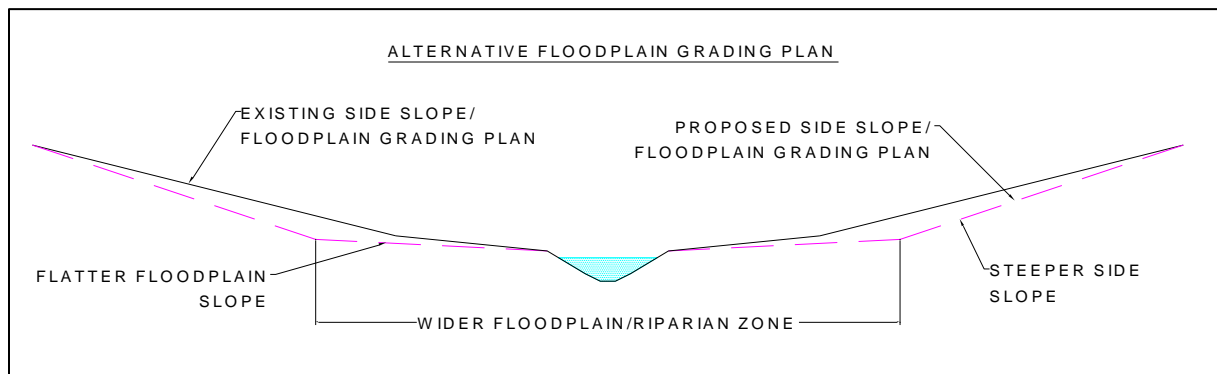
Figure 2. Alternative grading plan to increase floodplain and riparian areas.

The reconstructed channel segment of Spring Creek is designed with upland side slopes that transition to a narrow, 17.5-foot wide floodplain bench. Perpendicular transect survey results (Appendix B) illustrate floodplain slopes down to the channel which reduces the area available for overbank flooding to a narrow zone adjacent to the channel. This design configuration results in a relatively limited riparian/floodplain zone approximately three times wider than the active channel. Integrating a slightly steeper upland side slope design would provide for a wider, more functional floodplain and riparian zone by allowing the stream to access a larger, flat floodplain adjacent to the active channel (Figure 2). Constructing steeper side slopes and a wider floodplain area requires additional excavation; therefore, a cost/benefit analysis of creating additional floodplain and wetland features, and the associated mitigation credits, is potentially worth consideration for future stream and riparian mitigation designs.

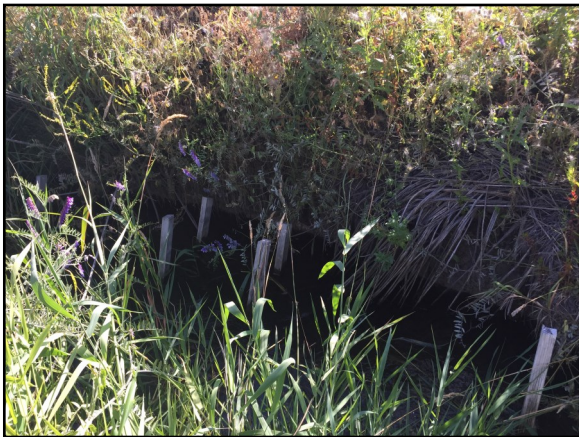
Additional Photo 2: 2016

In 2015, one 30-foot eroding bank was identified within the project reach (Figure 3, Appendix A). Inspection of this bank in 2016 revealed no additional bank retreat or increase in eroding bank length over the past year (See Additional Photo 2 in Appendix C). Erosion at this location is most likely due to degradation of coir logs used to construct the channel. The bank occurs approximately 30 feet downstream of a beaver dam, which may cause accelerated velocities during storm events just downstream. The adjacent riparian corridor is well vegetated with reed canary grass, Maximilian sunflower, and Canada thistle; however, little floodplain exists along the west side of the channel at this location to disperse energy during high flows. Based on the lack of continued erosion and a densely vegetated riparian zone adjacent to the bank, erosion severity along this bank segment is considered low.

The stream bank inventory identified one 30-foot long eroding bank segment that has retreated approximately 1-2 feet since the project was constructed. Observation of this bank in 2016 noted no additional lateral erosion or lengthening of the erosion. This bank segment represents less than 2% of the overall bank length of 1,990 feet. Erosion at this location appears as a result of decay of the coir logs used to construct the channel, and an undercut forming in its absence. Due to the relatively short eroding bank segment and the establishment of stable vegetation along the bank, corrective actions are not warranted. Performance criteria for the site allow for up to 25% of the stream banks to indicate signs of erosion or instability; as a result, the performance criterion for stream bank stability is currently being met. The Spring Creek mitigation site has continued to meet the bank stability success criteria since the initial monitoring event in 2013.

Description: Eroding stream bank
